**MAULDS MEABURN VILLAGE GREEN
CUMBRIA**

**The Condition and Management Requirements
of the Trees**

**Prepared at the request of
Crosby Ravensworth Parish Council**

01 December 2023

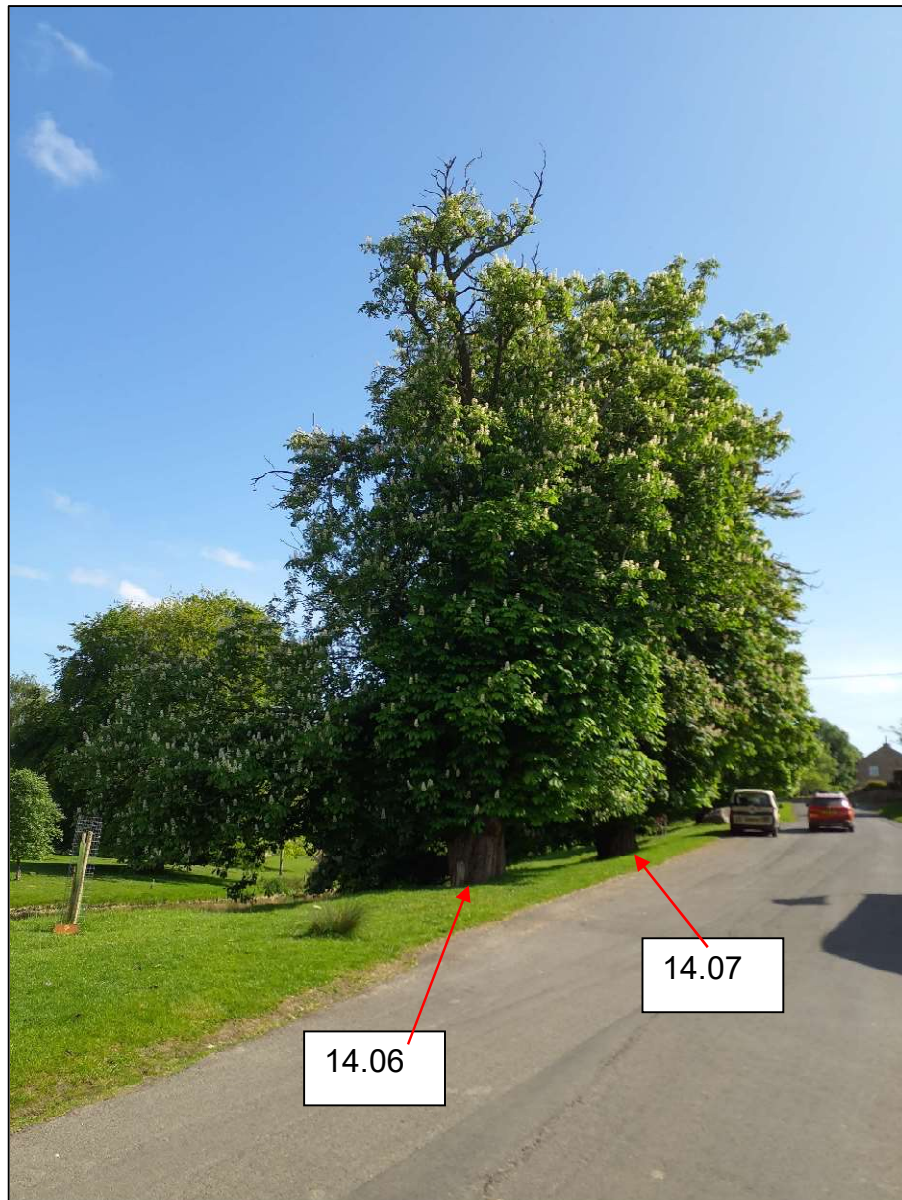
Photograph 1

I assessed both trees to be in the 'Early Decline' health class and Structural Condition Class C.

There is a cavity in the southern side of a stem of 14.07 at 3.8m.

I consider that, due to the reduced vitality of both trees, wood decay in the trunks and branches of the trees will be progressive. I therefore conclude that there is a relatively high and increasing risk that branches will break from either tree and some of these could impact on the road and parked cars.

Tree 14.06 from the north, north-west. There are dead twigs and branches in the upper crown of Tree 14.06 which indicate that its health is compromised. Tree 14.07 is behind tree 14.06.

- I recommend that trees 14.06 and 14.07 should be reduced or pollarded.
- Trees and shrubs which overhang roads, drives, footpaths and car parking areas, should be pruned, when necessary, to maintain suitable clearances above them.

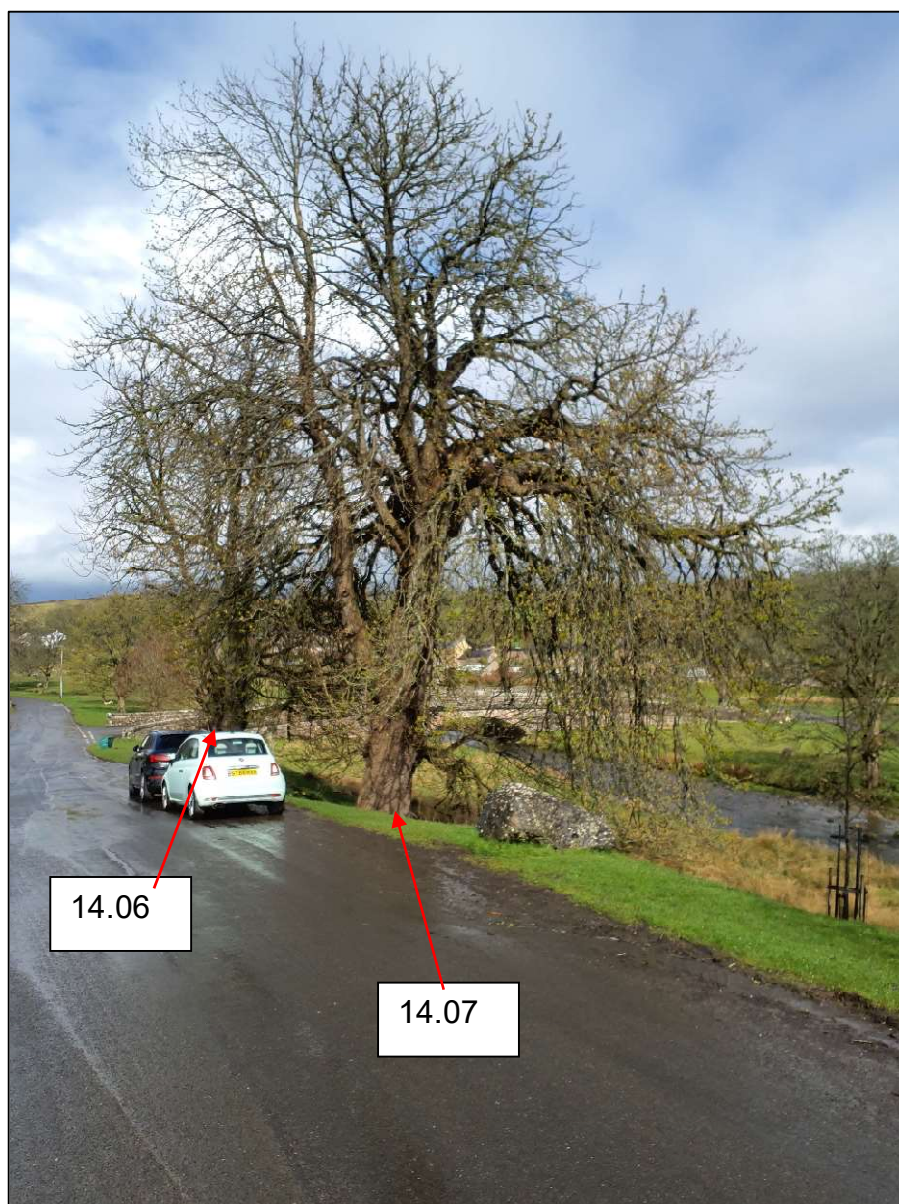
Photograph 2

The crown of trees 14.06 and 14.07 overhang the edge of the road where cars often park. The health of the upper crowns of both trees is compromised.
